CURVED RAILS, CURVED PLATFORM, CURVED CANOPY.

TIME TRAVEL ABOARD DANVILLE DEPOT.

Danville Depot Floor Plan and Elevations.

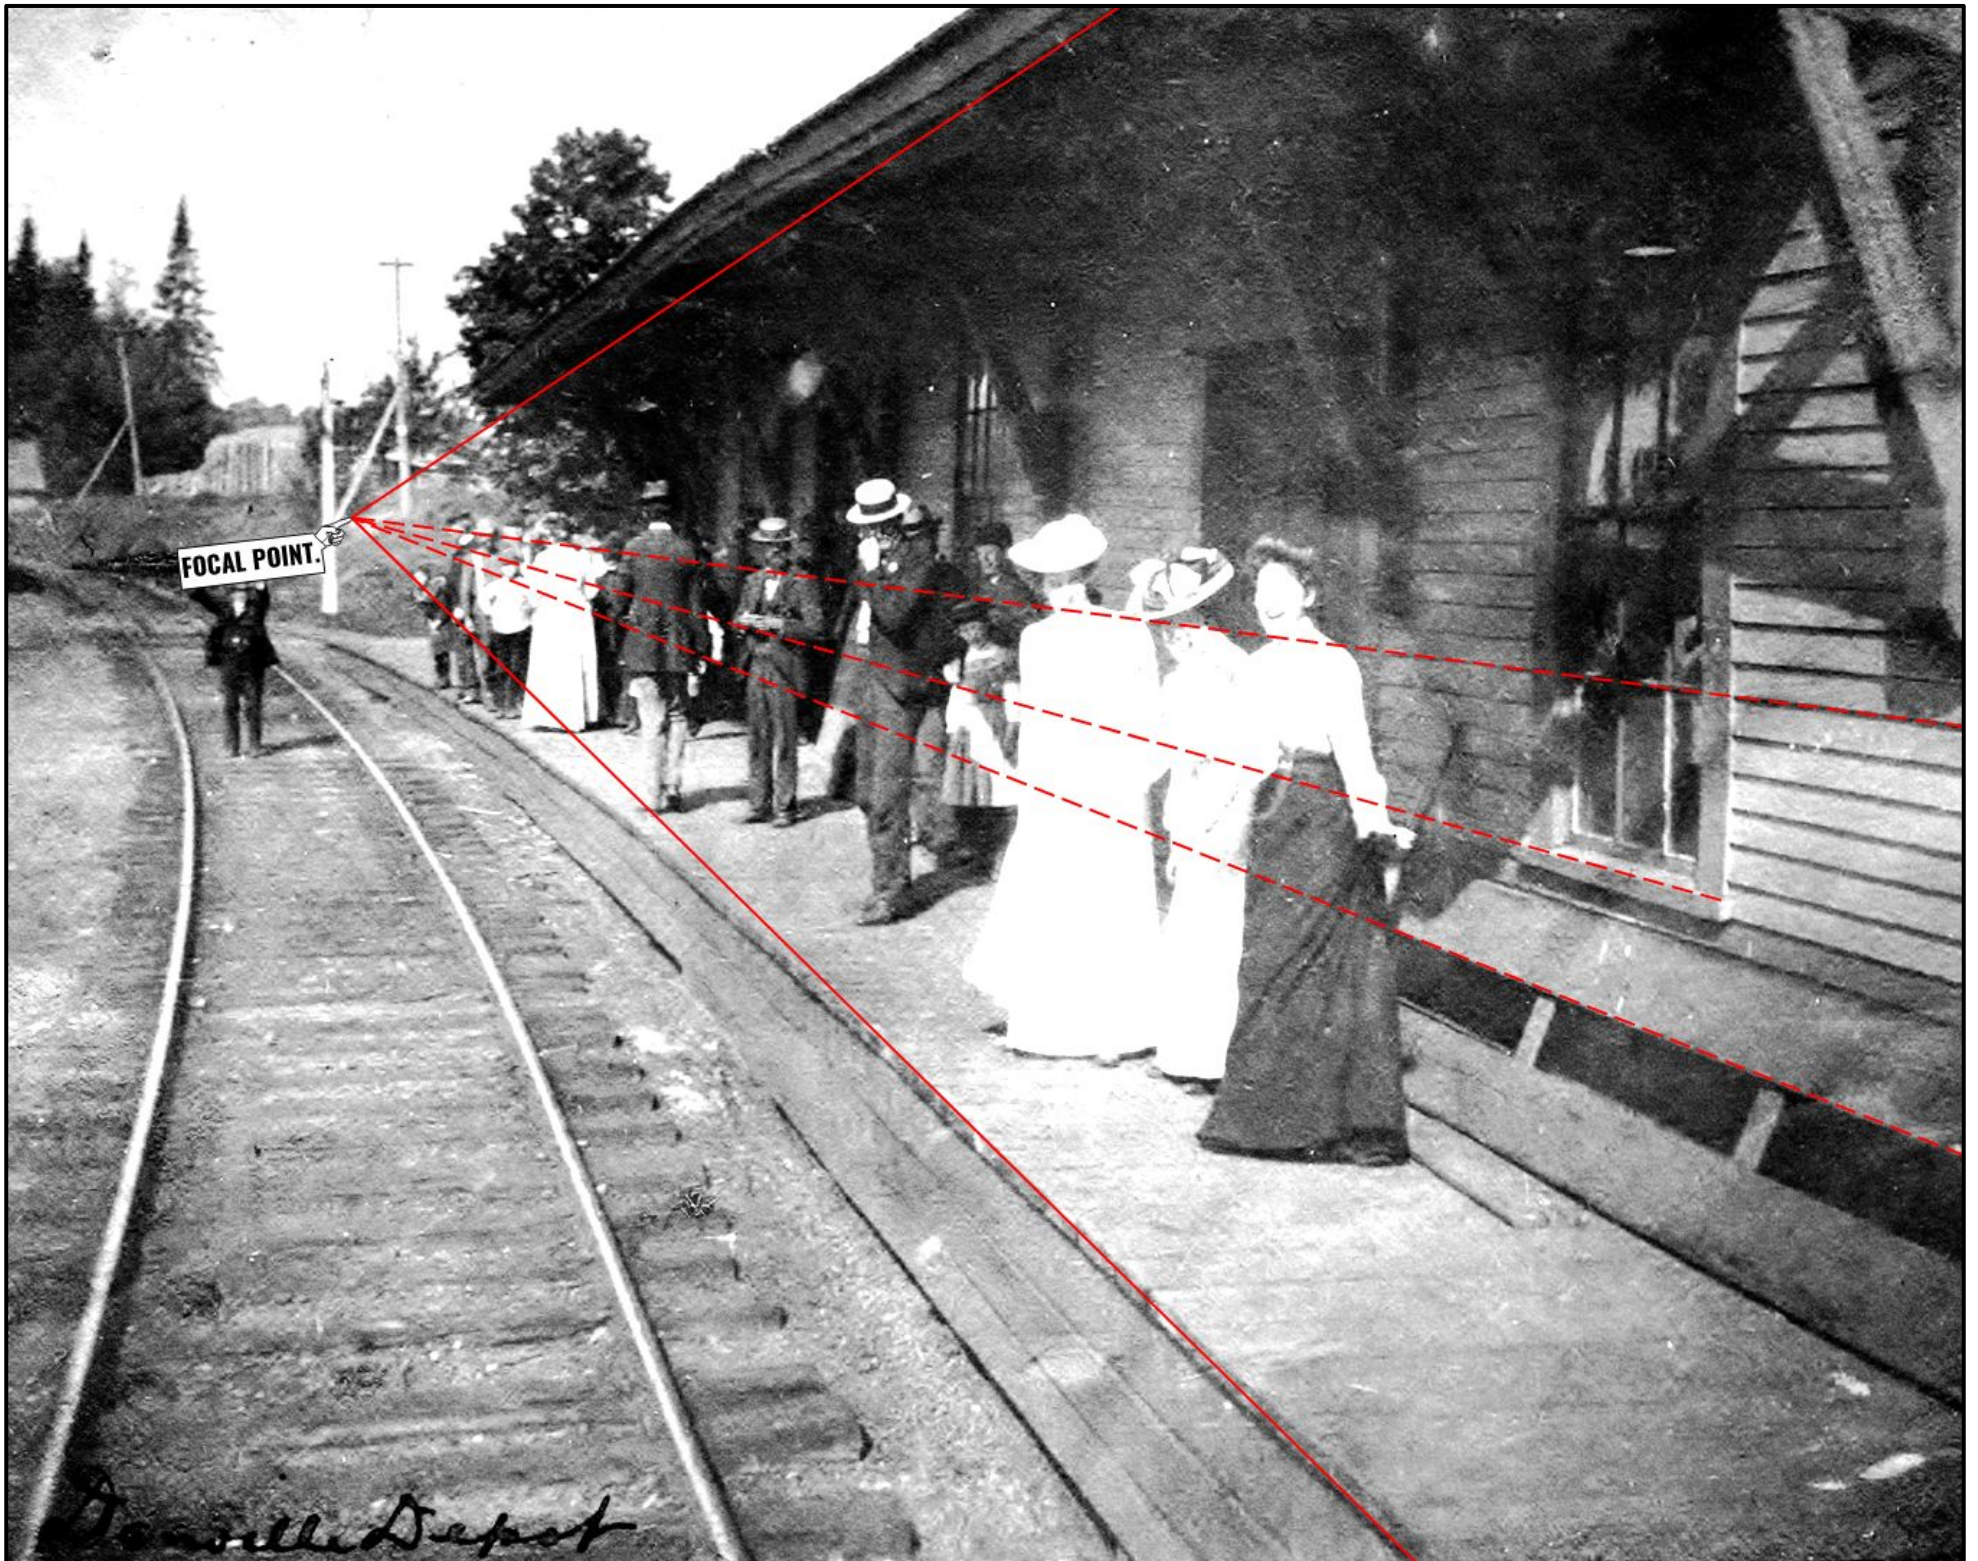
**Above - The Depot a Few Years Before
The Grand Circa 1907 Renovation.
- Danville Historical Society.**

Notice That The Canopy Roof Overhang Gets Gradually Shorter From West to East.

Above is a photograph taken of the south side of the depot a few years before the grand circa 1907 Renovation. In every image, there are natural lines that lead to focal points. By examining the lines in this picture, one can discern that the canopy and the platform do not appear to be on the natural lines that lead to the focal point of the rest of the depot. This suggests that both the canopy and the platform curved along the rails. Three brackets remain fully intact and are drawn below.

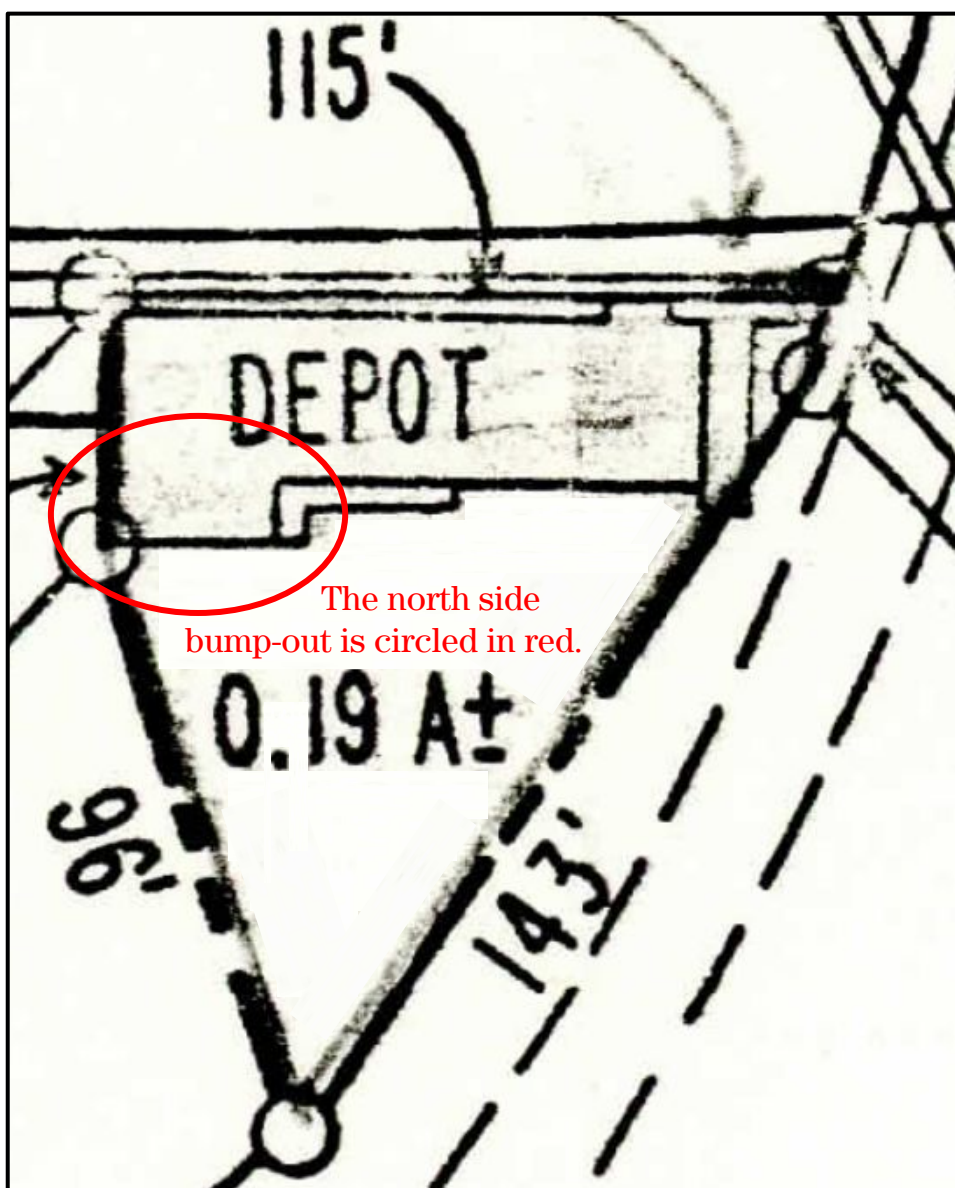
SURVEY MAP OF DANVILLE DEPOT FROM 1976 LEASE AGREEMENT.

From studying the 1976 lease agreement map closely, one can see a large bump-out on the north side of the building. Oddly enough, the footprint of the depot from the early 20th century with the elusive addition is drawn in the 1976 lease map even though the addition was pulled down a few decades before 1976. See the picture below to see what the depot looked like in 1976. This discrepancy might have been attributed to the surveyor tracing their map from an older map. It is not the first time this sort of discrepancy has occurred. (See next page.)

According to the 1976 Lease Agreement map, the platform extended approximately fifty feet down the trail from the southeast corner of the building.

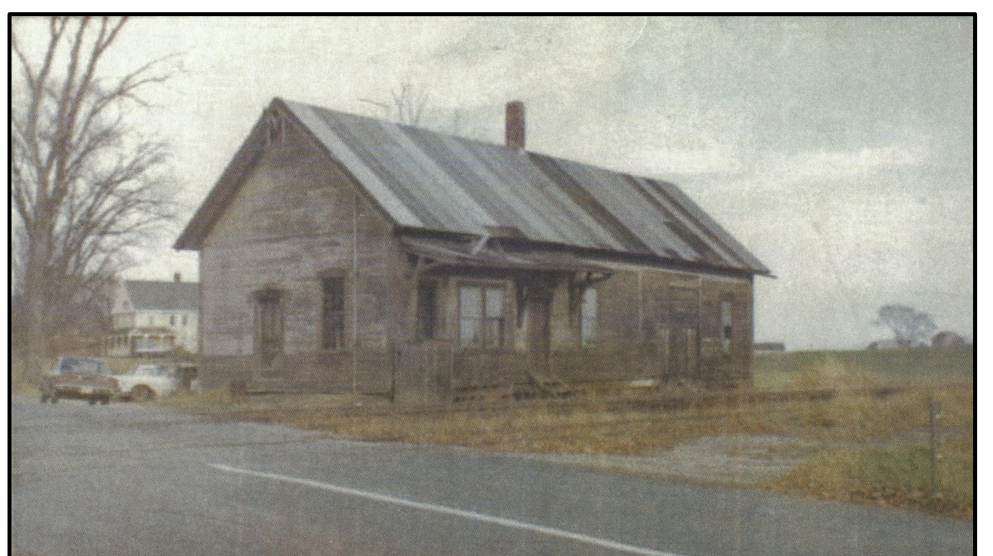
The depot shortly before the 1976 renovation.

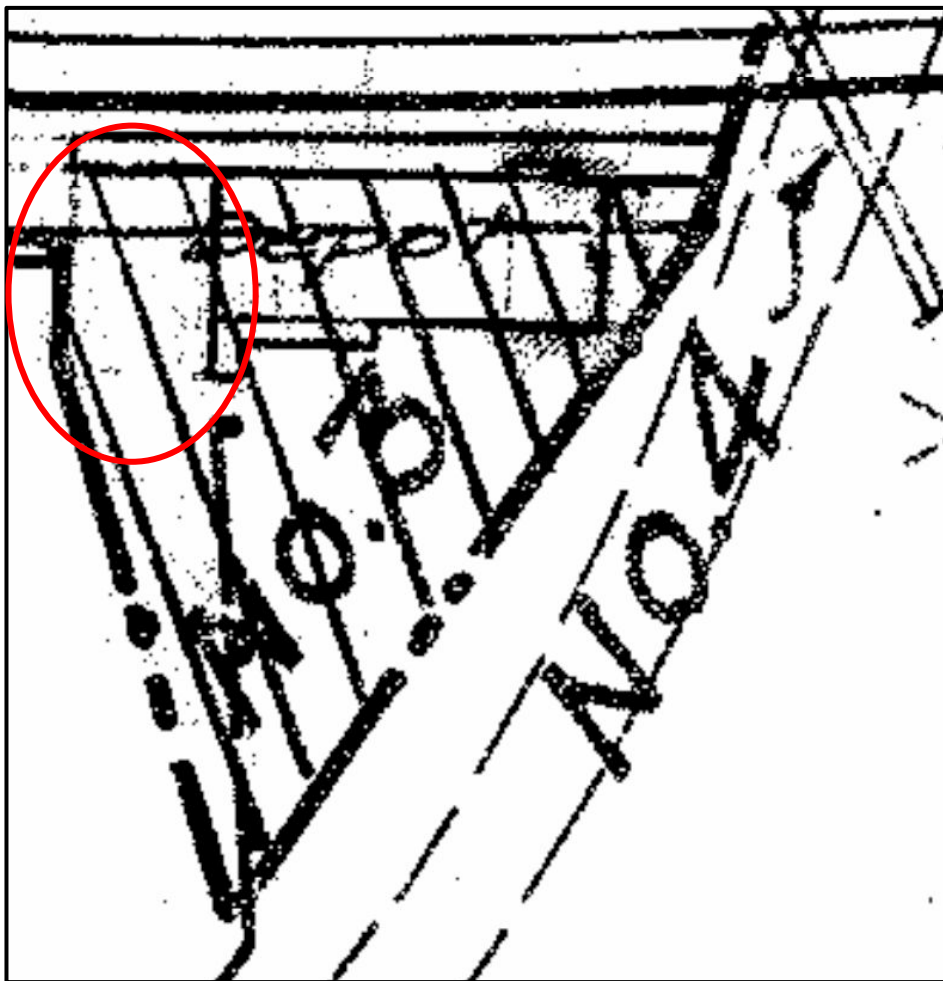
Right-of-Way Track Map. Operated by the The ST J & LC R.R. Co. June 30, 1916.

The addition is not drawn in this 1916 map even though it was built before this map was drawn.

Surprisingly enough, this is not the first time a surveyor traced a map of Danville Depot and its plot. Our surveyors in 1916 were likely too focused on clearly depicting the right-of-way of the tracks and at the crossing that they did not notice that they were referencing a map of the depot that neither had the addition nor the full length of the trackside platform. What we see instead is the depot's footprint before the addition was built and the expansion of the platform.

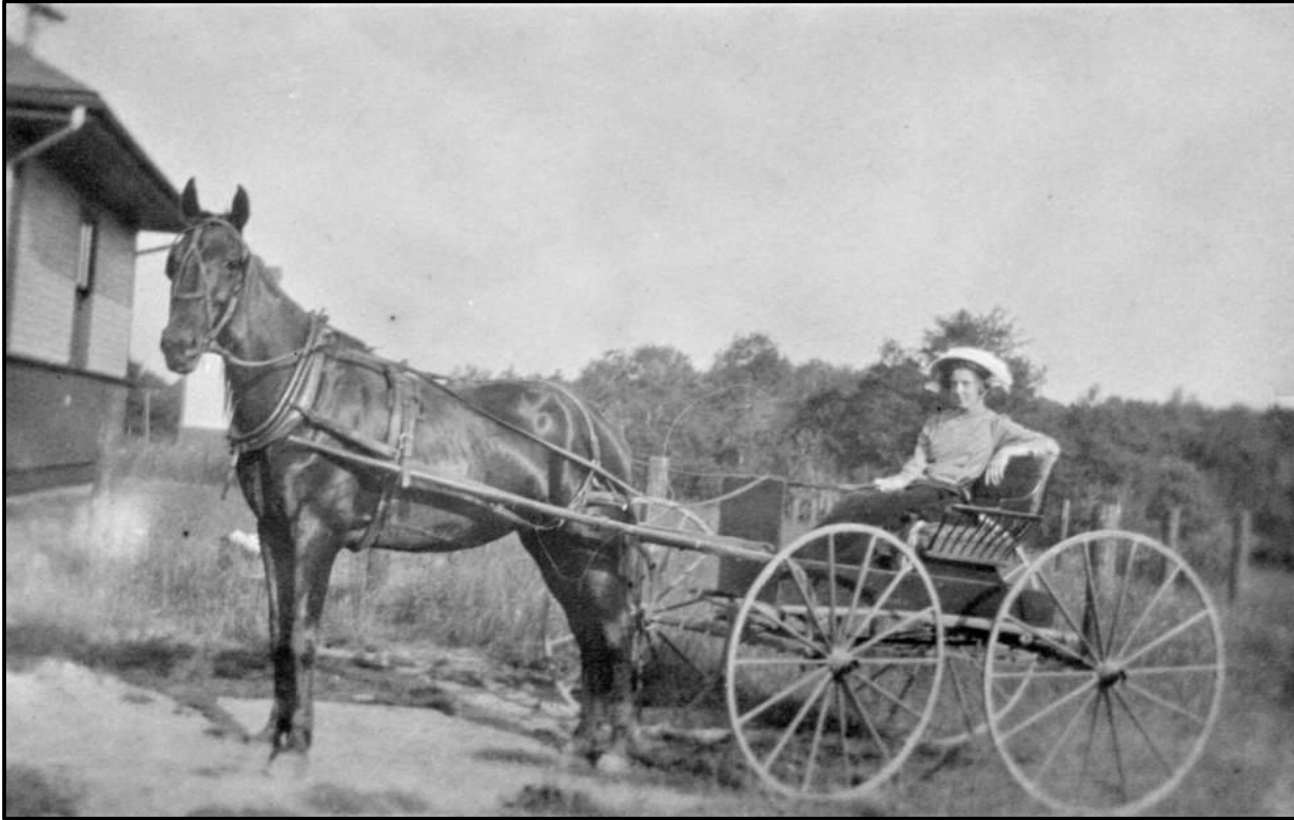
Ella Page in her horse and buggy at Danville R.R. Station.
- Danville Historical Society.

The overhang of a gable above the roof of the bump-out is visible in the top right corner of the photograph.

The photograph above has often been seen as horizontally flipped so that Ella Page is on the right of the picture. The result it is unintelligible to discern what side of the station the photograph depicts. We can only make sense of the picture by correcting the orientation as featured above.

Now that the photograph returned to the correct orientation, it is clear that the north bump-out, seen on the lease map (page one), is in the background with some outbuilding behind the horse's neck. There are no rails on the ground; therefore, this photograph could not have been taken on the south side. The corner of the addition and the overhang of its gable being visible above the roof of the bump-out indicate that the bump-out is towards the east of the north side.

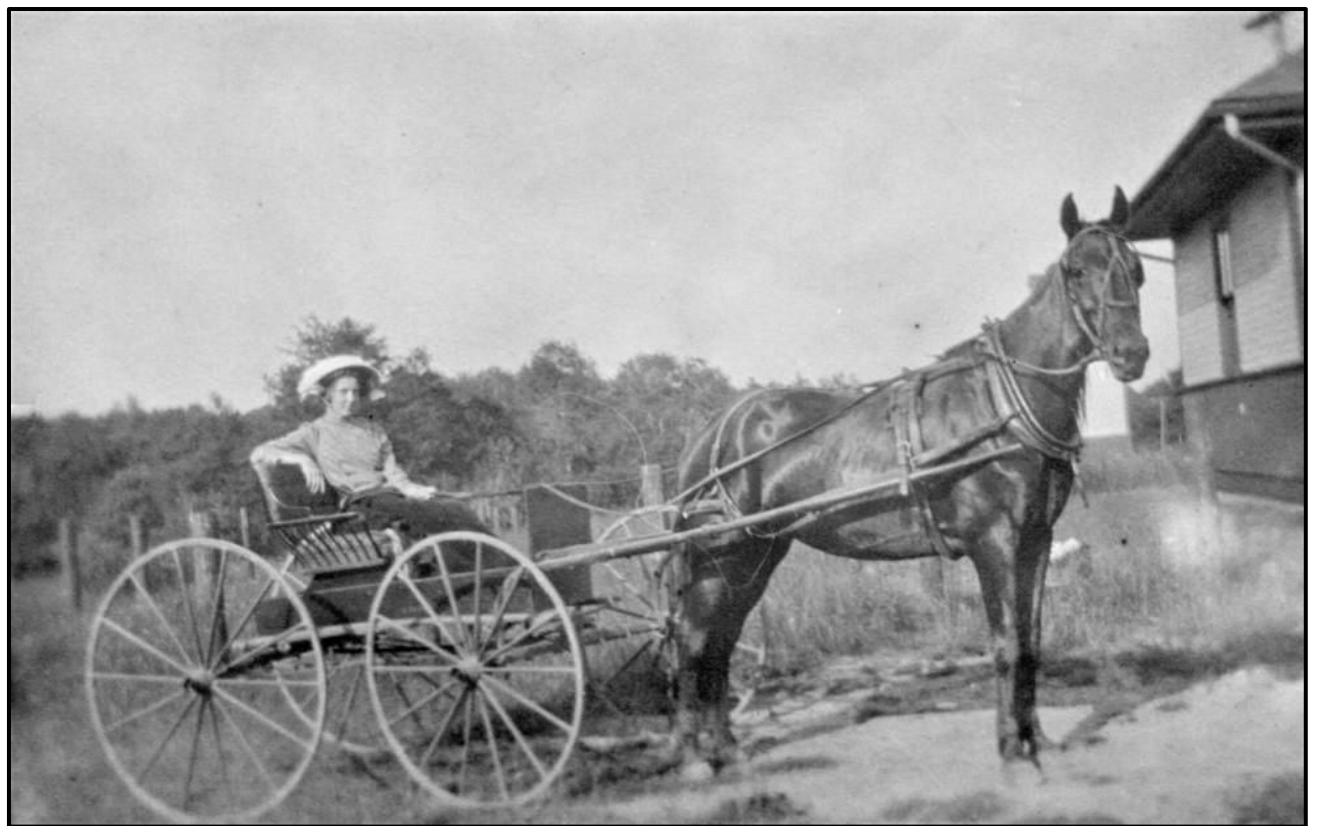
Ella Page in her horse and buggy at Danville R.R. Station.
- Danville Historical Society.

Flipped horizontally to the correct orientation. Read the explanation below.

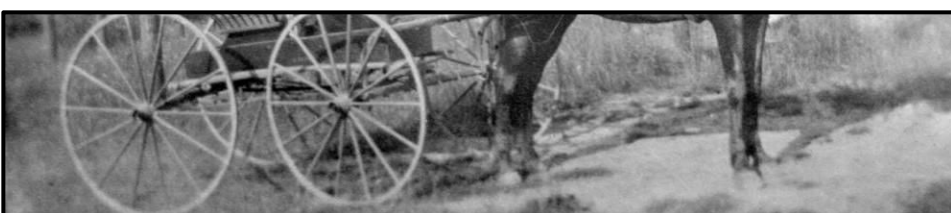
The rails are on the south side of the depot, No rails are visible on the ground; therefore, this cannot be on the south side of the building.

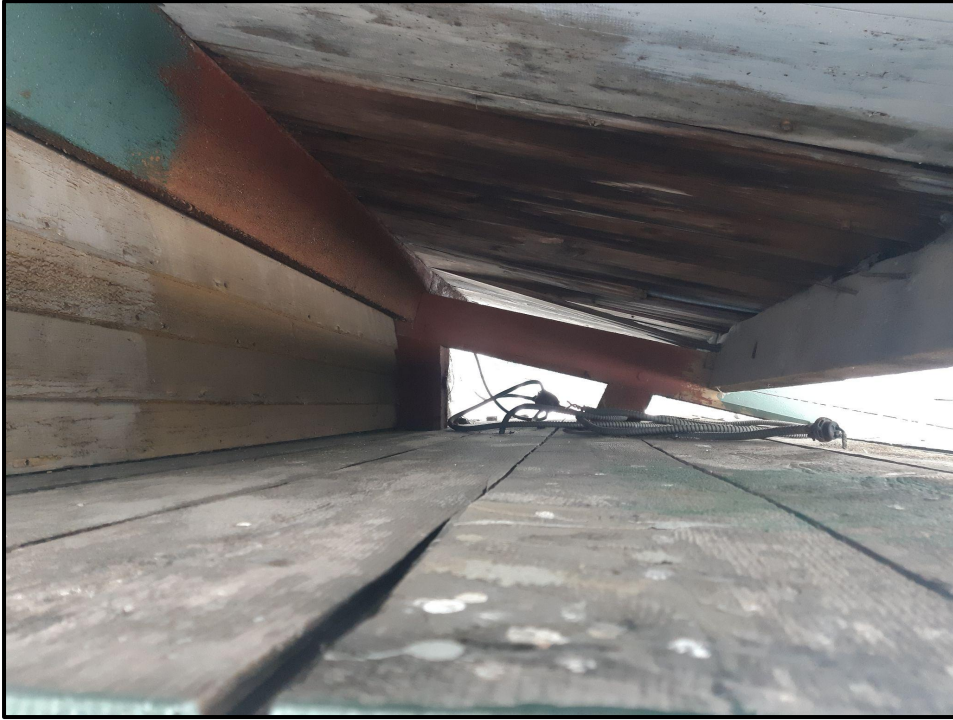
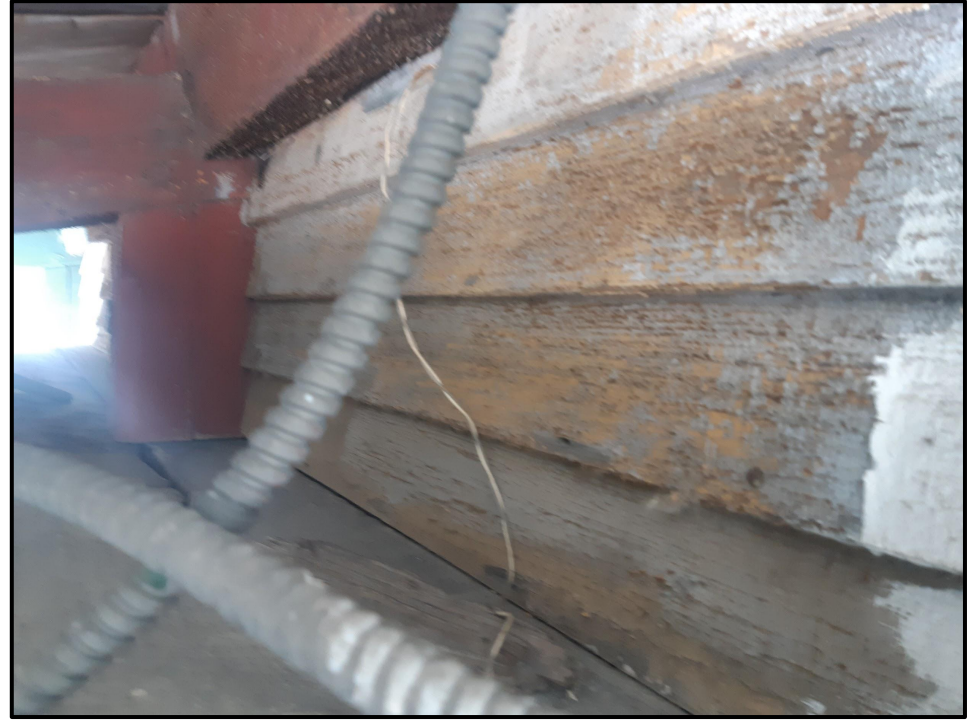
Ochre and Red Paint above the Ticket Office Window on the south side.

Above the ticket office window on the south side of the depot, there is an area, painted ochre and red, which is not visible from the ground and inaccessible to any painters; thus, it has not been painted over since a large renovation that took place some time around 1907; which is known because of the patent date discovered by, Michael Hogue, while refurbishing the Glenwood in the waiting room and the supporting photographic evidence seen on this page. The ticket office window was one of many new features of this renovation.

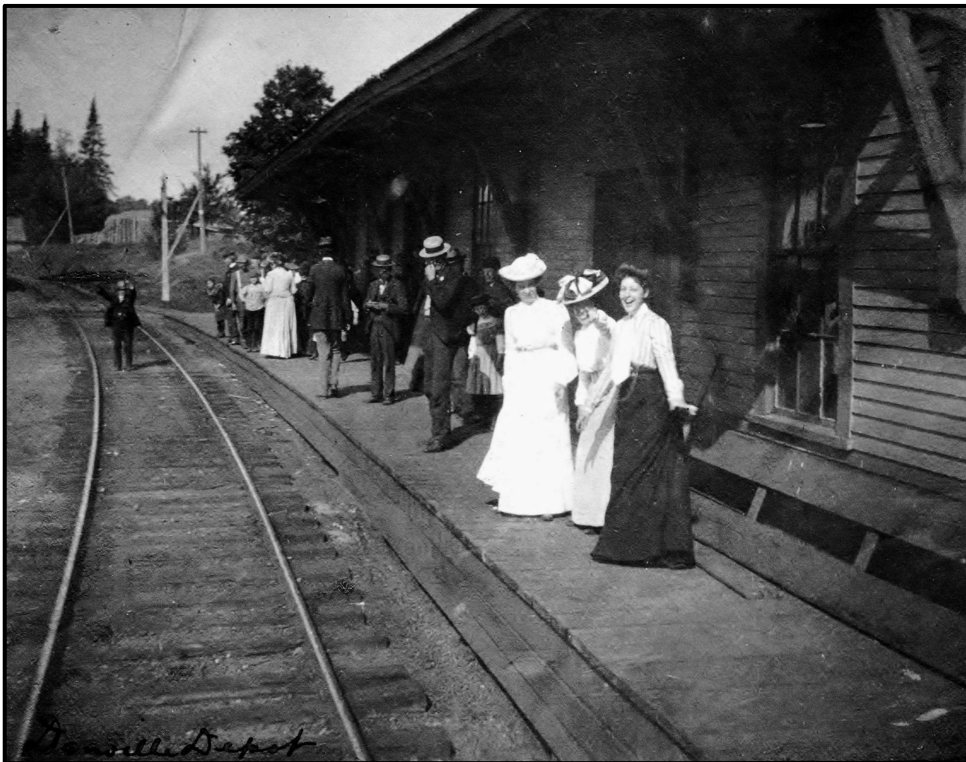
**Trackside of Danville Depot Around 1905.
- Danville Historical Society.**

A two-tone color scheme is visible in the photograph above, taken sometime around 1905 before the grand circa 1907 renovation. We know this because of the women's fashion in the pictures. We can see a Gibson Girl hairstyle, several examples of shirtwaists, bishop sleeves, and pigeon chest, all characteristic of fashion from around 1905.

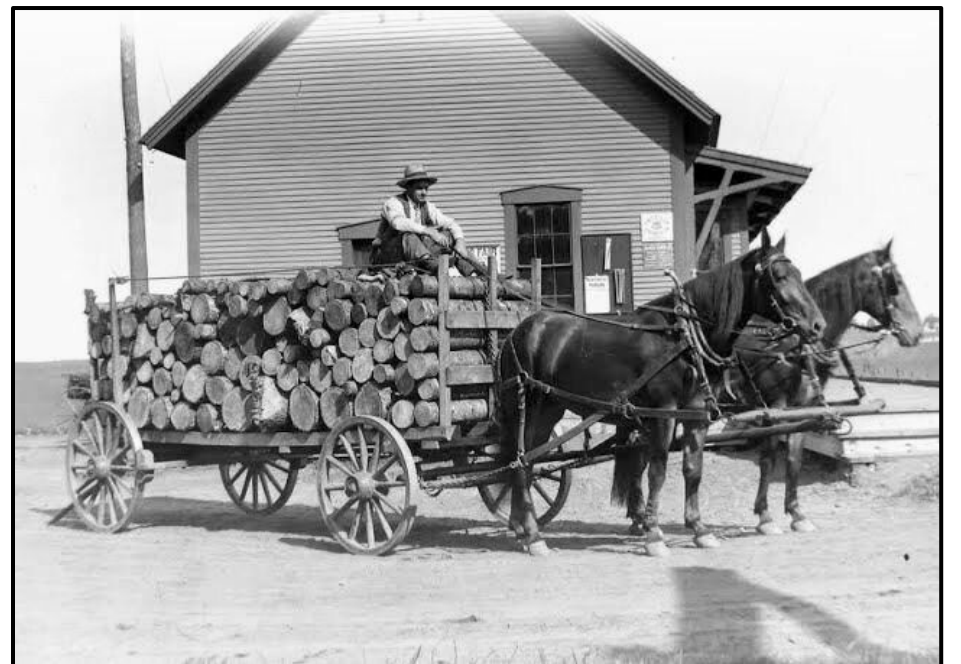
**C. H. Davis with Load of Wood - 1908
in Front of Danville Railroad Station.
- Danville Historical Society.**

Above is the new façade of the depot shortly after the circa 1907 renovation. The photograph of C. H. Davis was inscribed with the date 1908. The ticket office bump-out is also visible behind one of the horses' heads, erected as part of the renovation.

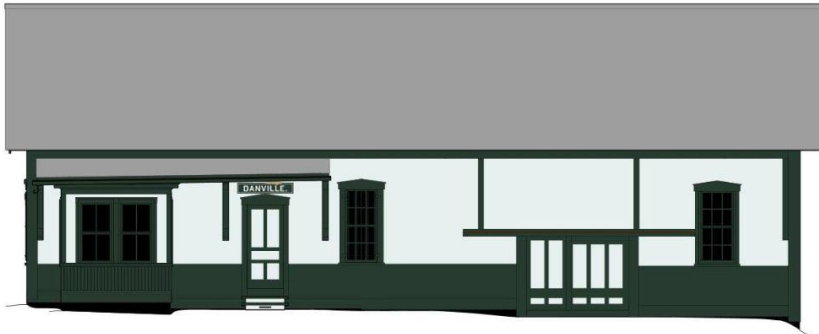
2021 South Elevation.

Scale: 1/16" = 1'

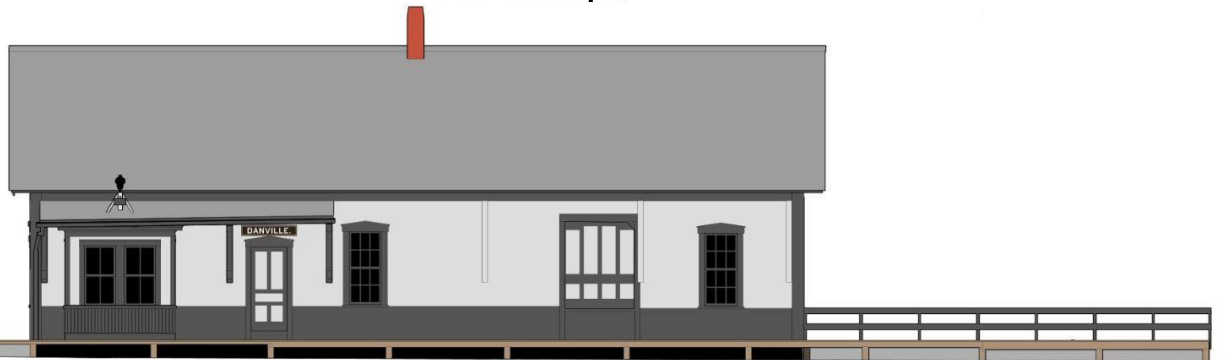
Circa 1954 South Elevation.

Scale: 1/16" = 1'

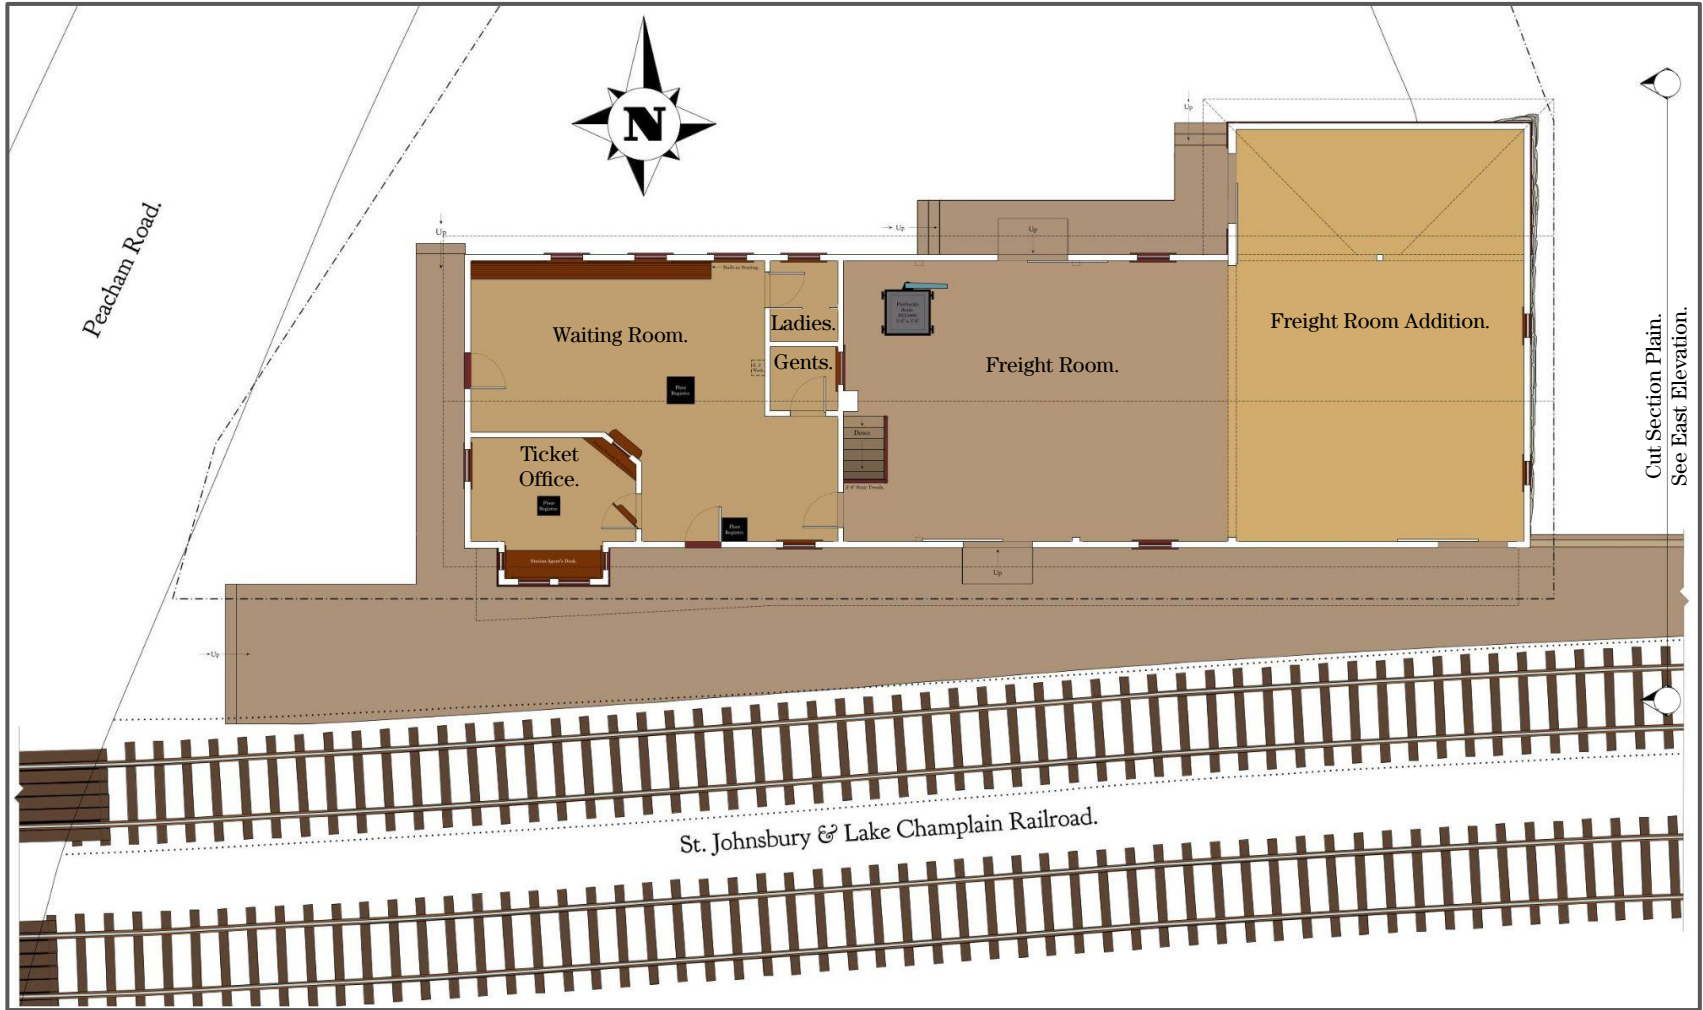
Circa 1916 Danville Depot Floor Plan and Elevations.

The dimensions of the addition, some of the dimensions of the platform, and the placement of the north freight room door were determined using measurements from drawings commissioned by the Interstate Commerce Commission on July 10th, 1916. These drawings were published in The St. Johnsbury and Lake Champlain Railroad Plans by R. W. Nimke in 1994.

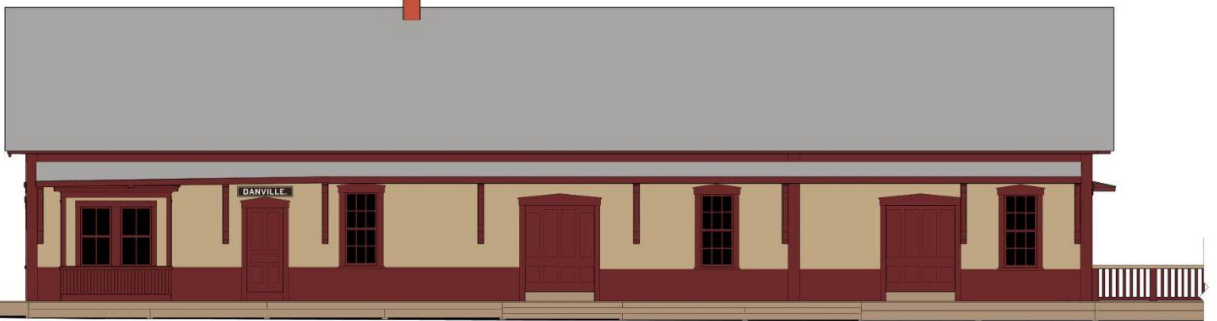
Circa 1907 South Elevation.

Scale: 1/16" = 1'
